**Flood Control Project Maintenance
Levee Inspections**
LMA District Cover Sheet
Spring 2017 Levee Inspection Results

Marysville Levee Commission

Spring 2017 Levee Inspection Results

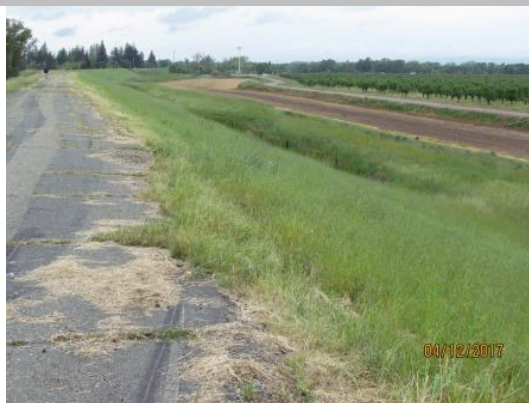
Photo 1 of 1 : SP_2017_NA0004_104_13_20170414_00024.jpg

View looking downstream of annual grasses, Spring 2017.

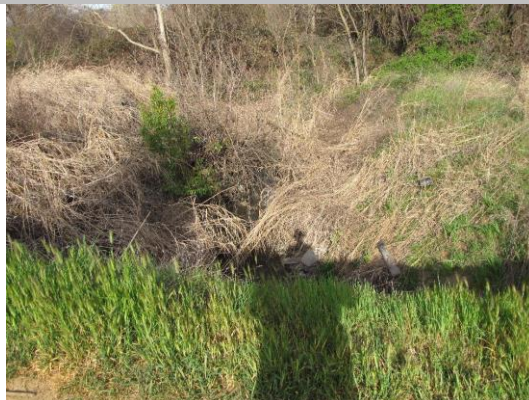
Photo 2 of 3 : UCIP_SP_2017_42945_69743.jpg

View of waterward side from toe road.

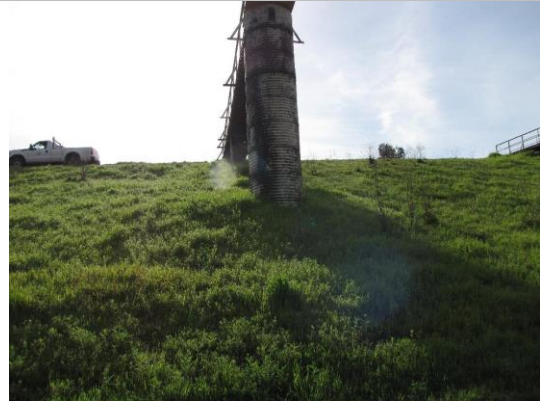
Photo 3 of 3 : UCIP_SP_2017_42945_69742.jpg

View of waterward slope.

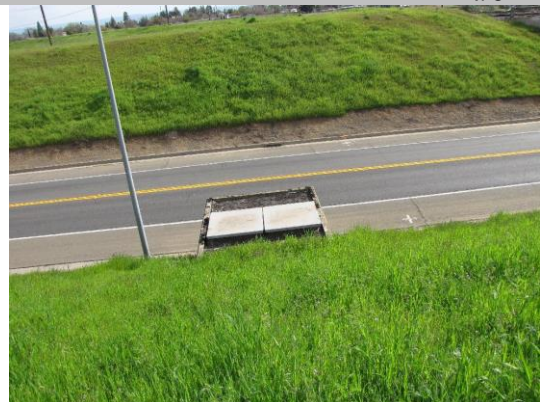
Photo 1 of 3 : UCIP_SP_2017_40931_69758.jpg

LM Start	0.96	Rating **	M	Issue No.	38
LM End	0.96	Issue Type +	En	Location *	WS
Category	Supplemental			GPS Latitude/Longitude	
				Start	End
Item	DWR UCIP Field Study			39.158946 °	39.158946 °
				-121.589930 °	-121.589930 °
DWR ID					
Comment Code					
Inspector Comment					
FS_ID:40931 DS_ID:19100 EP_NO: 14518 Repair Type: Non-Urgent Crossing Status: Indicator Found UCIP Comments: Recommend having owner removing tall grass along slopes to properly inspect signs of pipe failure. FIELD_STRUCT_DESC: 1 of 2: 10-inch steel pipe through levee, 4.0 feet below crown. Flap gate on waterward end. Concrete vault on waterward shoulder. Metal meter box on the landward shoulder. Pump placed on concrete footings at toe of landward slope. Drainage for underpass. Pipes approx. 2.5-feet apart. (Permit No. 14518-1987). FS Date: 3/14/2013

View of landward side.

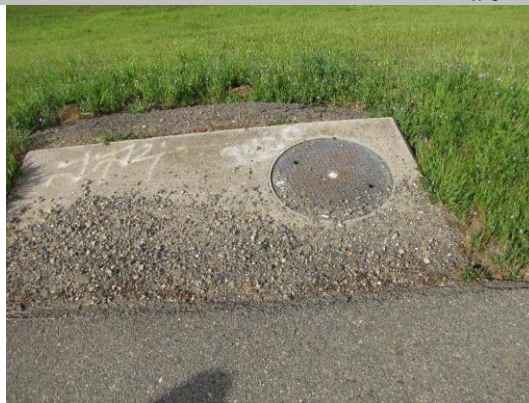
Photo 2 of 3 : UCIP_SP_2017_40931_69757.jpg

Concrete vault on waterward shoulder with manhole.

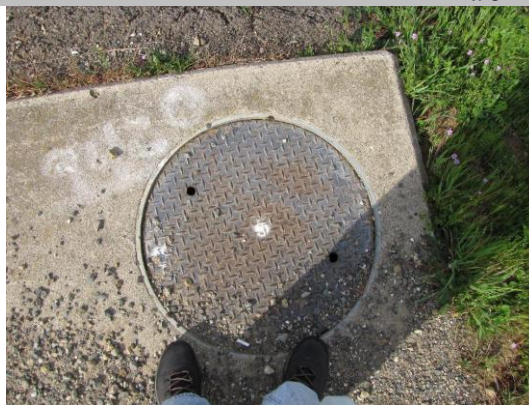
Photo 3 of 3 : UCIP_SP_2017_40931_69756.jpg

Close up view of manhole.

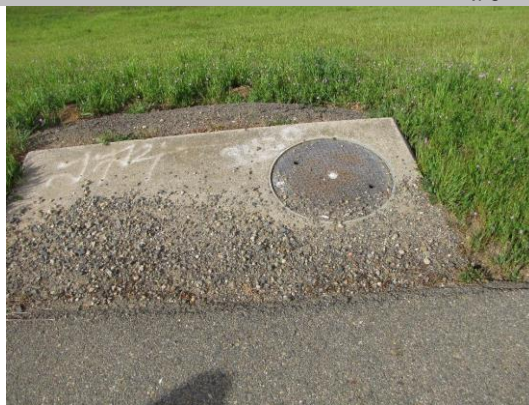
Photo 2 of 3 : UCIP_SP_2017_40933_69761.jpg

Concrete vault located on waterward shoulder.

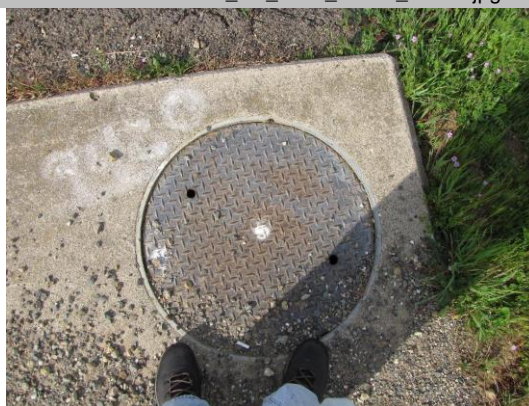
Photo 3 of 3 : UCIP_SP_2017_40933_69760.jpg

Close up of manhole.

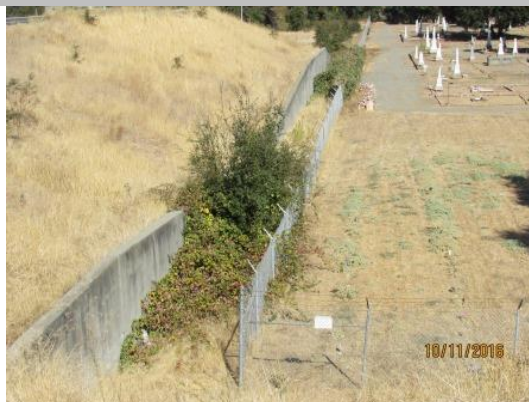
Photo 1 of 1 : SP_2017_NA0004_104_36_20170316_00004.jpg

LM Start	0.97	Rating **	M	Issue No.	36
LM End	1.19	Issue Type +	Ob	Location *	WS
Category	Earthen Levee			GPS Latitude/Longitude	
				Start	End
Item	Encroachments			39.159210 °	39.161576 °
				-121.590033 °	-121.590721 °
DWR ID	DWR_NA0004_01_f_2013_36				
Comment Code					
RW : Retaining Wall					
Inspector Comment					
Concrete retaining wall cut into levee toe, no permit found.

View of the concrete retaining wall at the toe of the levee on the waterward side looking downstream.

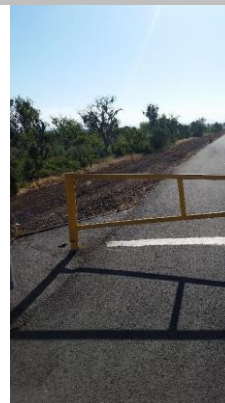
Photo 1 of 3 : UCIP_SP_2017_51917_75785.jpg

LM Start	1.99	Rating **	U	Issue No.	41
LM End	1.99	Issue Type +	En	Location *	LS
Category	Supplemental			GPS Latitude/Longitude	
				Start	End
Item	DWR UCIP Field Study			39.164957 °	39.164957 °
				-121.581832 °	-121.581832 °
DWR ID					
Comment Code					
Inspector Comment					
FS_ID:51917					
DS_ID:25467					
EP_NO: N/A					
Repair Type: Urgent					
Crossing Status: Not Found					
UCIP Comments: 6/29/2016 Per Frank Miller, LMA Contact, the					
USACE has identified an 8-inch gas line through levee. Unable to					
confirm owner, permit, or depth of crossing. (DWR UCIP - omagana)					
FIELD_STRUCT_DESC: 8-inch gas line of unknown material through					
the levee at an unknown depth.					
FS Date: 6/29/2016

View of levee crown where crossing goes through levee--no markers visible, photo 1 of 2.

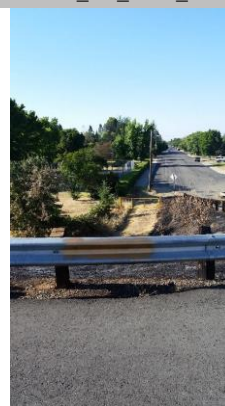
Photo 3 of 3 : UCIP_SP_2017_51917_75787.jpg

View of LS.

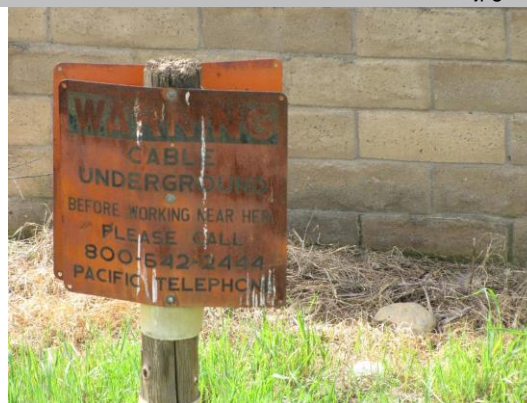
Photo 1 of 3 : UCIP_SP_2017_40935_69766.jpg

LM Start	3.19	Rating **	M	Issue No.	42
LM End	3.19	Issue Type +	En	Location *	LS
Category	Supplemental			GPS Latitude/Longitude	
				Start	End
Item	DWR UCIP Field Study			39.163888 °	39.163888 °
				-121.560262 °	-121.560262 °
DWR ID					
Comment Code					
Inspector Comment					
FS_ID:40935					
DS_ID:19115					
EP_NO: 12878					
Repair Type: Non-Urgent					
Crossing Status: Indicator Found					
UCIP Comments: Need to contact owner to determine additional information about crossing and alignment.					
FIELD_STRUCT_DESC: 24-inch steel pipe encasing 4-inch PVC communications extension through the levee, annular gap grouted, 8 feet below levee crown. Cutoff wall (12x12x20-inch) around extension from levee slopes. (Permit No. 12878-1980).					
FS Date: 3/14/2013

Marker on landward side.

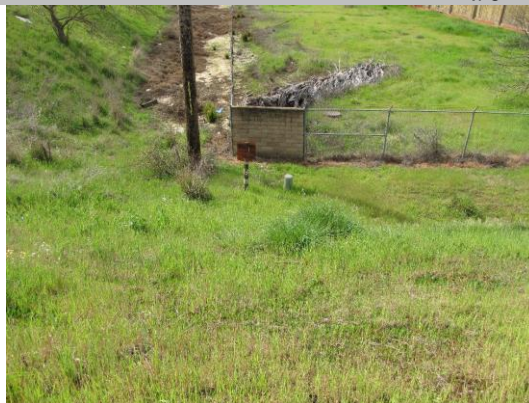
Photo 2 of 3 : UCIP_SP_2017_40935_69765.jpg

View of landward side.

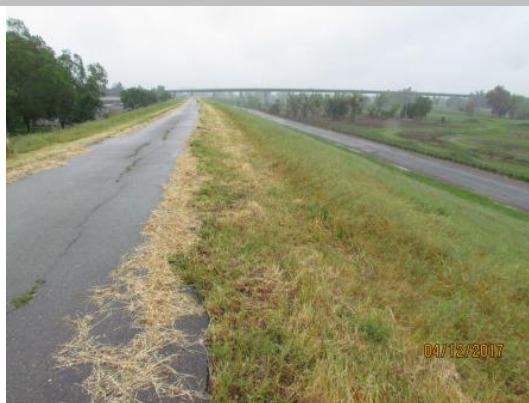
Photo 1 of 1 : SP_2017_NA0004_105_7_20170414_00018.jpg

View looking downstream of annual grasses, Spring 2016.

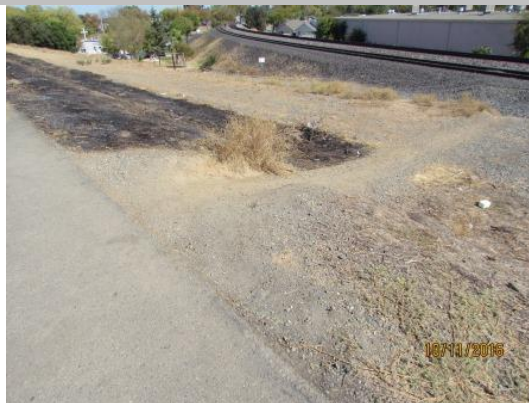
Photo 1 of 1 : SP_2017_NA0004_105_8_20170316_00003.jpg

LM Start	0.22	Rating **	M	Issue No.	8
LM End	0.22	Issue Type +	Ma	Location *	LS
Category	Earthen Levee			GPS Latitude/Longitude	
				Start	End
Item	Slope Stability			39.146352 °	39.146352 °
				-121.600724 °	-121.600724 °
DWR ID	DWR_NA0004_02_f_2016_8				
Comment Code					
S2 : Repair the levee slope damaged by foot traffic and prevent access where possible.					
Inspector Comment					
Foot path depression in the landside levee slope needs repaired. Fall 2016.

View of foot path depression in the landside levee slope.

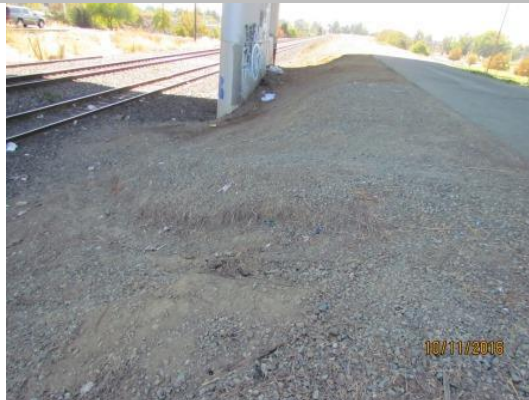
Photo 1 of 1 : SP_2017_NA0004_105_6_20170316_00002.jpg

LM Start	0.31	Rating **	A/W	Issue No.	6
LM End	0.31	Issue Type +	Ma	Location *	LS
Category	Earthen Levee			GPS Latitude/Longitude	
				Start	End
Item	Slope Stability			39.144990 °	39.144990 °
				-121.600576 °	-121.600576 °
DWR ID	DWR_NA0004_02_s_2015_6				
Comment Code					
S2 : Repair the levee slope damaged by foot traffic and prevent access where possible.					
Inspector Comment					
Tire ruts in the landside levee slope has been repaired, Spring 2017.

View of tire ruts in the landside levee slope. For Spring 2017 the rut depressions in the landside levee slope has been repaired.

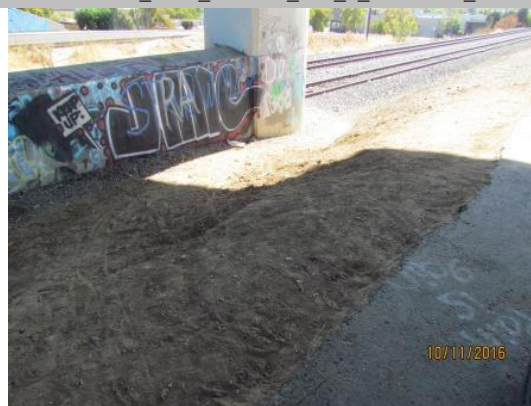
Photo 1 of 1 : SP_2017_NA0004_105_4_20170316_00001.jpg

LM Start	0.32	Rating **	A/W	Issue No.	4
LM End	0.32	Issue Type +	Ma	Location *	LS
Category	Earthen Levee			GPS Latitude/Longitude	
				Start	End
Item	Slope Stability			39.144840 °	39.144840 °
				-121.600559 °	-121.600559 °
DWR ID	DWR_NA0004_02_s_2016_4				
Comment Code					
S2 : Repair the levee slope damaged by foot traffic and prevent access where possible.					
Inspector Comment					
Foot path depression in the landside levee slope has been repaired, Spring 2017.

View looking downstream of landside slope erosion due to heavy foot traffic. Fall 2016. For Spring 2017 the foot path depression in the landside levee slope has been repaired.

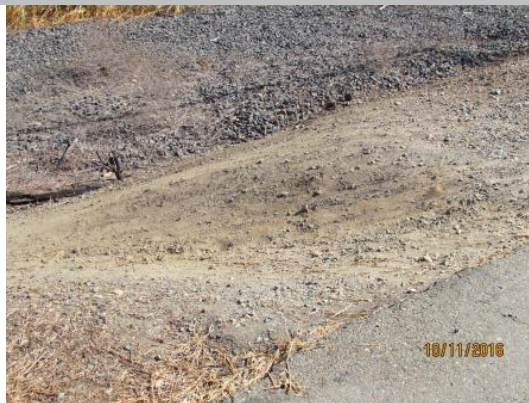
Photo 1 of 1 : SP_2017_NA0004_105_13_20170316_00008.jpg

LM Start	0.82	Rating **	M	Issue No.	13
LM End	0.82	Issue Type +	Ma	Location *	LS
Category	Earthen Levee			GPS Latitude/Longitude	
				Start	End
Item	Slope Stability			39.138827 °	39.138827 °
				-121.599530 °	-121.599530 °
DWR ID	DWR_NA0004_02_f_2016_13				
Comment Code					
S2 : Repair the levee slope damaged by foot traffic and prevent access where possible.					
Inspector Comment					
Foot path depression in the landside levee slope needs repaired.

View of foot path depression in the landside levee slope.

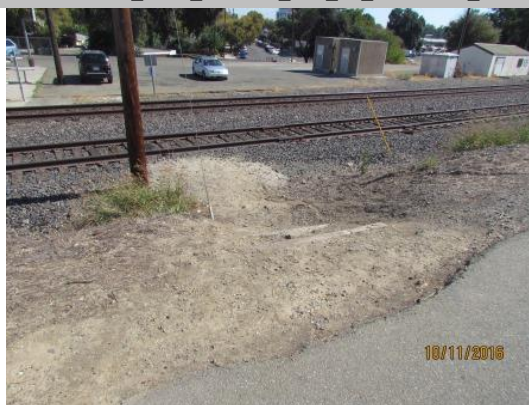
Photo 1 of 1 : SP_2017_NA0004_105_14_20170316_00009.jpg

LM Start	0.85	Rating **	M	Issue No.	14
LM End	0.85	Issue Type +	Ma	Location *	LS
Category	Earthen Levee			GPS Latitude/Longitude	
				Start	End
Item	Slope Stability			39.138463 °	39.138463 °
				-121.599168 °	-121.599168 °
DWR ID	DWR_NA0004_02_f_2016_14				
Comment Code					
S2 : Repair the levee slope damaged by foot traffic and prevent access where possible.					
Inspector Comment					
Remove steps that are cut into levee slope.

View of steps for foot path in the landside levee slope.

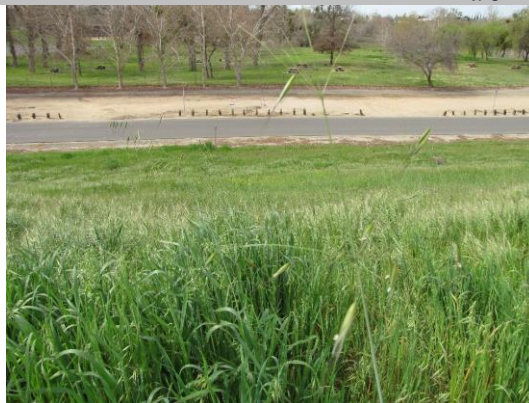
Photo 1 of 3 : UCIP_SP_2017_40940_69802.jpg

LM Start	0.87	Rating **	M	Issue No.	17
LM End	0.87	Issue Type +	En	Location *	LS
Category	Supplemental			GPS Latitude/Longitude	
				Start	End
Item	DWR UCIP Field Study			39.138269 °	39.138269 °
				-121.599004 °	-121.599004 °
DWR ID					
Comment Code					
Inspector Comment					
FS_ID:40940					
DS_ID:19123					
EP_NO: N/A					
Repair Type: Non-Urgent					
Crossing Status: Indicator Found					
UCIP Comments: Unable to tell if crossing goes through levee; according to Frank Miller crossing does not cross levee. Need to contact owner to confirm alignment.					
FIELD_STRUCT_DESC: Fiber optics communication line through levee. Marker on waterward shoulder.					
FS Date: 3/15/2013

View of waterward slope.

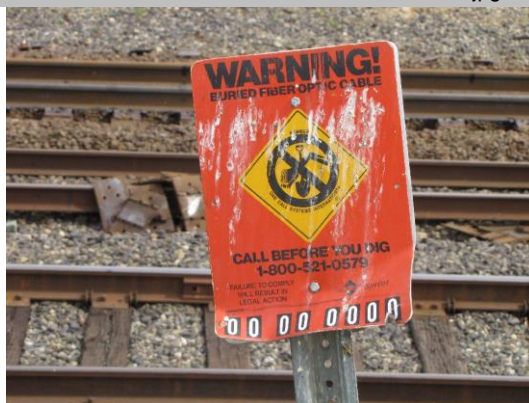
Photo 2 of 3 : UCIP_SP_2017_40940_69801.jpg

Buried fiber optical cable marker with contact information located on landward shoulder.

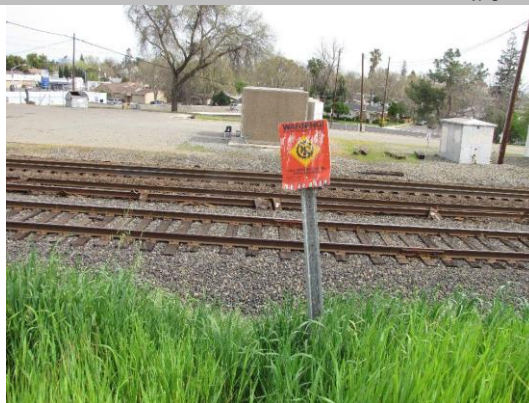
Photo 3 of 3 : UCIP_SP_2017_40940_69800.jpg

View of landward side with bldg that could be associated with cable line.

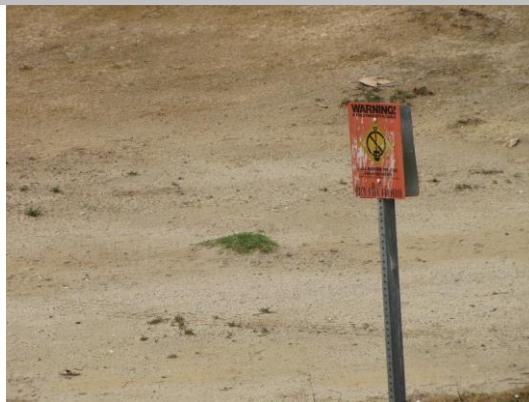
Photo 2 of 3 : UCIP_SP_2017_38272_69805.jpg

View of markers located on waterward toe.

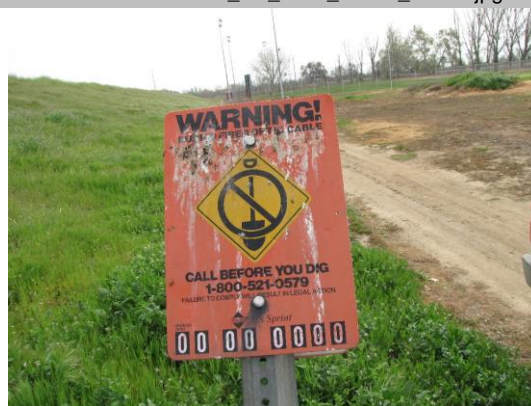
Photo 3 of 3 : UCIP_SP_2017_38272_69806.jpg

Close up of markers located at toe of waterward side.

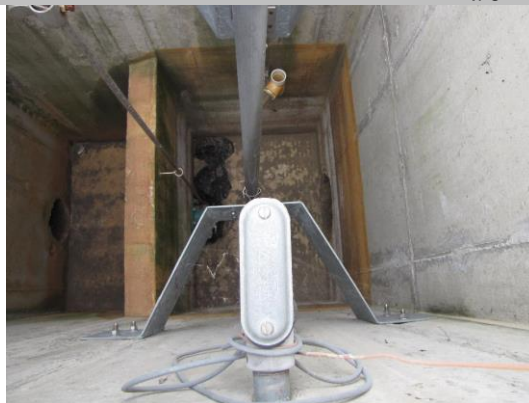
Photo 1 of 2 : UCIP_SP_2017_41024_72681.jpg

Inside view of concrete box.

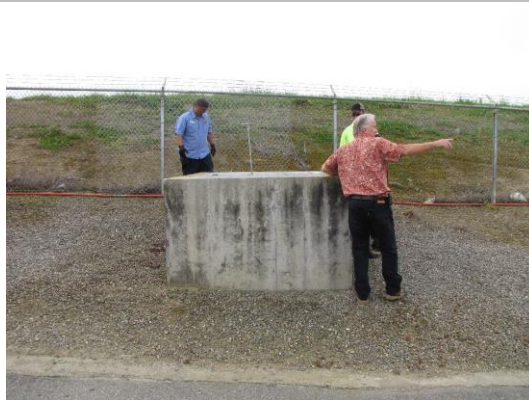
Photo 2 of 2 : UCIP_SP_2017_41024_72680.jpg

View of concrete box located on landward side--crossing not in use according to Marysville Sewage Treatment Plant Manager.

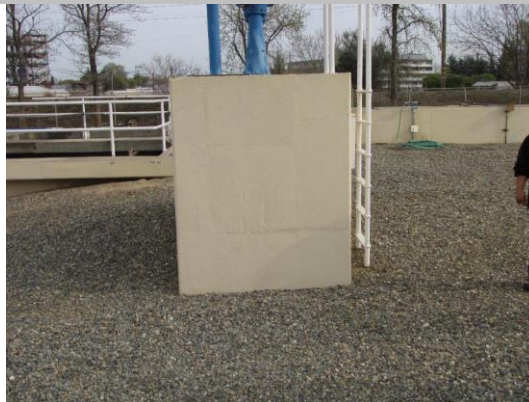
Photo 2 of 3 : UCIP_SP_2017_41025_69811.jpg

Standpipe where old line is still located.

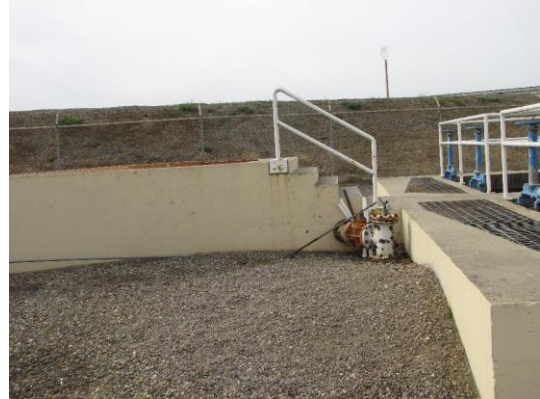
Photo 3 of 3 : UCIP_SP_2017_41025_69810.jpg

View of levee slope on waterward.

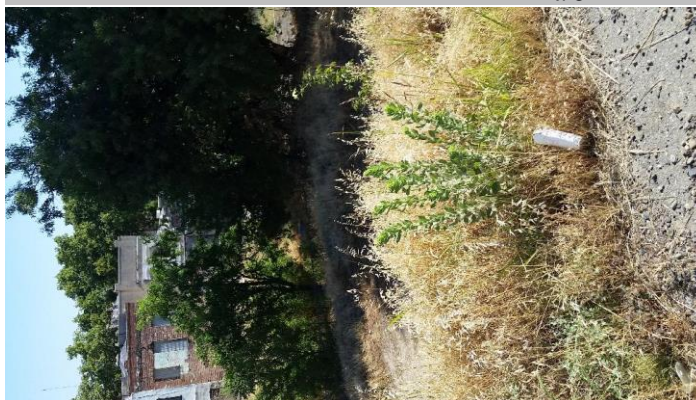
Photo 1 of 3 : UCIP_SP_2017_49942_75434.jpg

View of LS slope--no markers found.

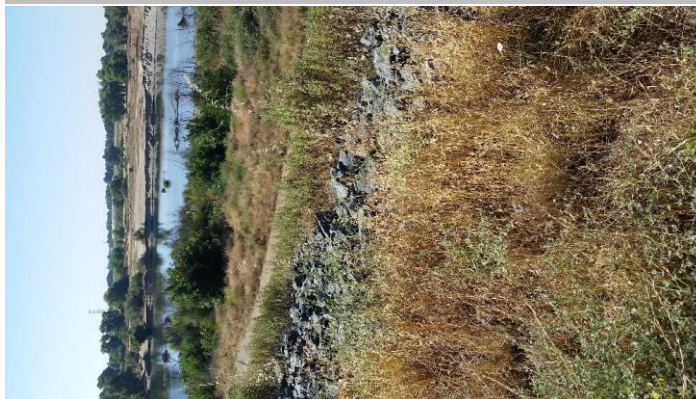
Photo 2 of 3 : UCIP_SP_2017_49942_75435.jpg

View of WS slope--no markers found.

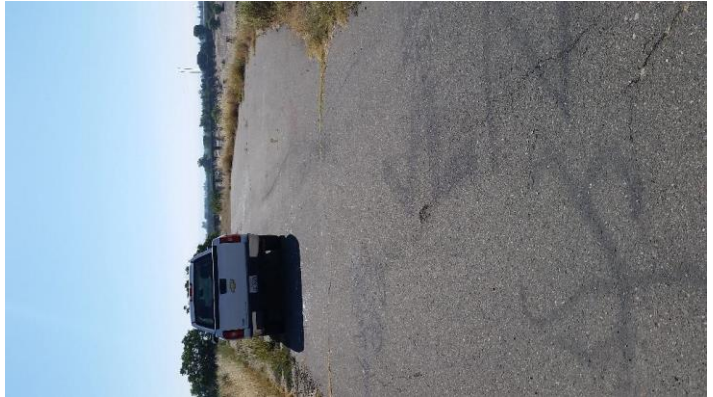
Photo 3 of 3 : UCIP_SP_2017_49942_75436.jpg

View of levee crown at approximate crossing location.

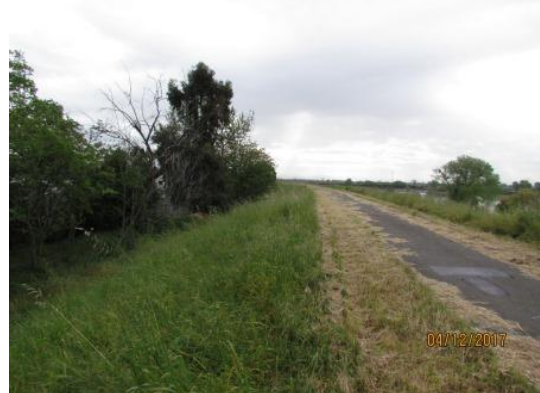
Photo 1 of 1 : SP_2017_NA0004_106_29_20170414_00069.jpg

View looking upstream of the landside slope where the annual vegetation maintenance needs to be completed. Spring 2017.

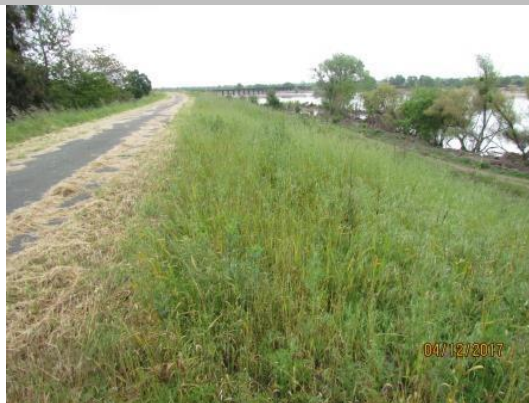
Photo 1 of 1 : SP_2017_NA0004_106_27_20170414_00070.jpg

View looking upstream of the waterside slope where the annual vegetation maintenance needs to be completed. Spring 2017.

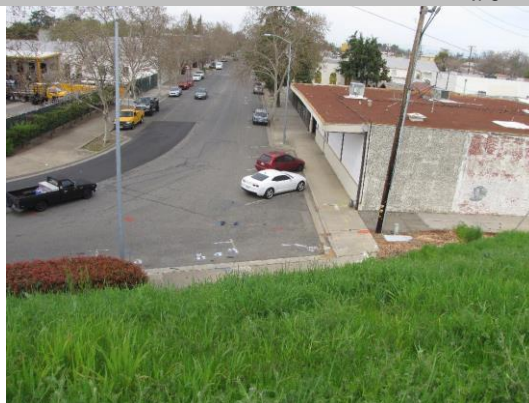
Photo 1 of 2 : UCIP_SP_2017_40969_72683.jpg

Underground service alert (USA) blue paint indicators of water line present on landward side.

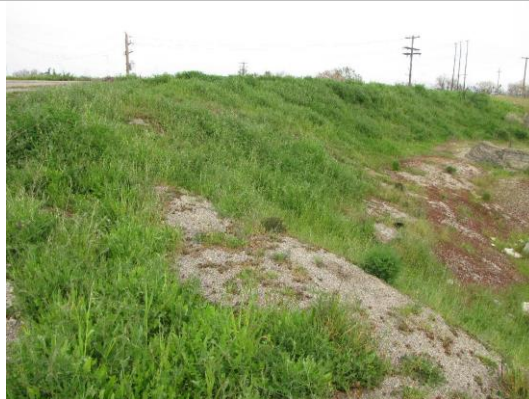
Photo 2 of 2 : UCIP_SP_2017_40969_72682.jpg

View of waterward slope--unable to confirm if crossing is active--line buried.

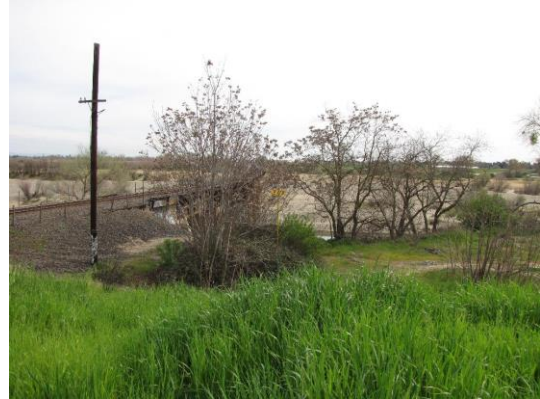
Photo 1 of 3 : UCIP_SP_2017_49947_72690.jpg

View of WS--marker visible inside channel.

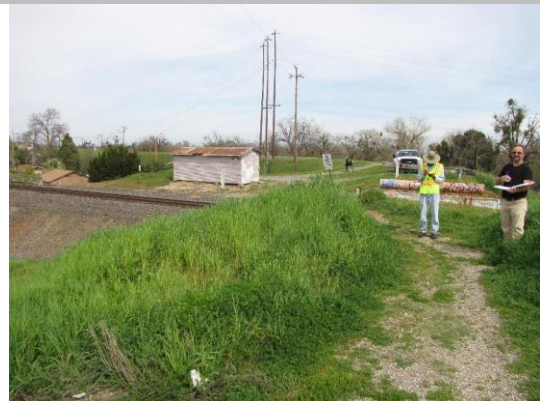
Photo 2 of 3 : UCIP_SP_2017_49947_72689.jpg

View of upstream levee.

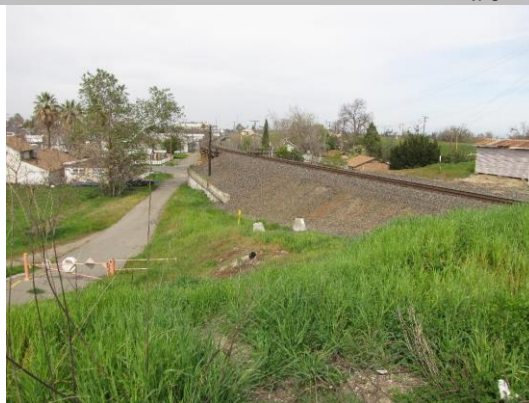
Photo 3 of 3 : UCIP_SP_2017_49947_72688.jpg

Marker visible on LS.

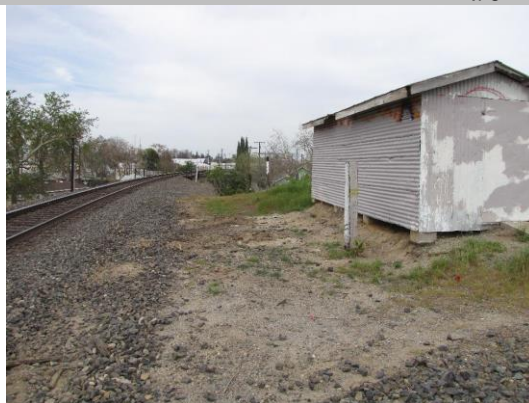
Photo 1 of 3 : UCIP_SP_2017_40975_72696.jpg

View of landward side.

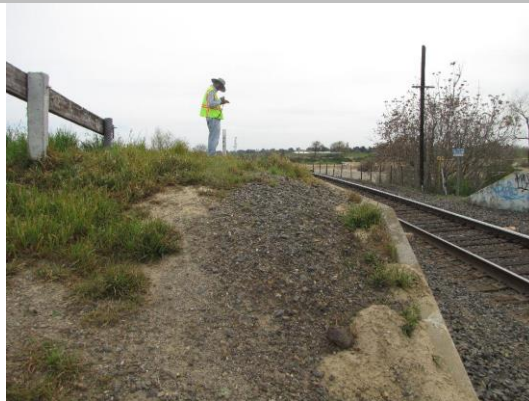
Photo 2 of 3 : UCIP_SP_2017_40975_72695.jpg

View of landward side.

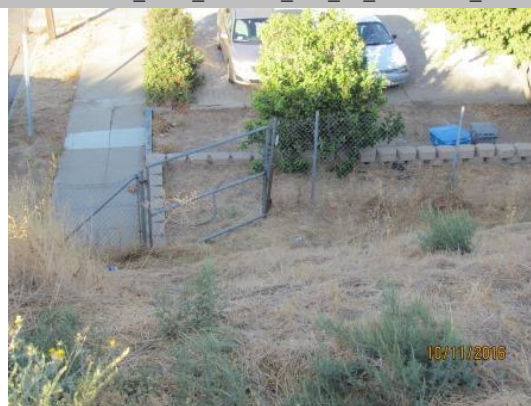
Photo 1 of 1 : SP_2017_NA0004_106_26_20170316_00008.jpg

View of fence that runs along landside levee toe.

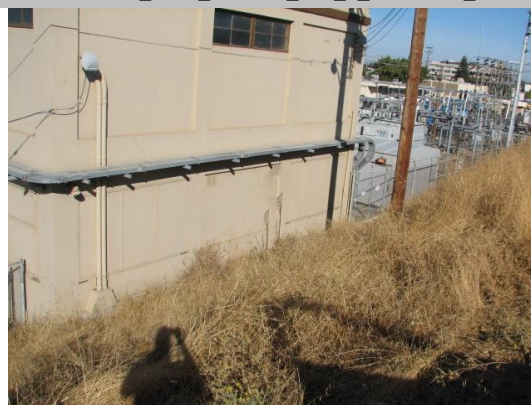
Photo 1 of 1 : SP_2017_NA0004_106_4_20170316_00003.jpg

Building encroaching at landside levee toe.

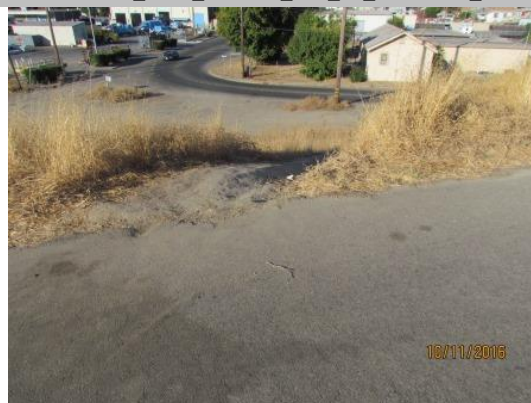
Photo 1 of 1 : SP_2017_NA0004_106_30_20170316_00011.jpg

View of path cut in by foot traffic on the landside slope.

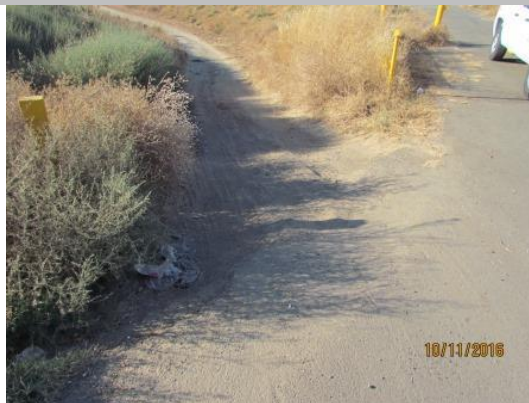
Photo 1 of 1 : SP_2017_NA0004_106_32_20170316_00012.jpg

View of ruts cut in by vehicle traffic on the waterside slope.

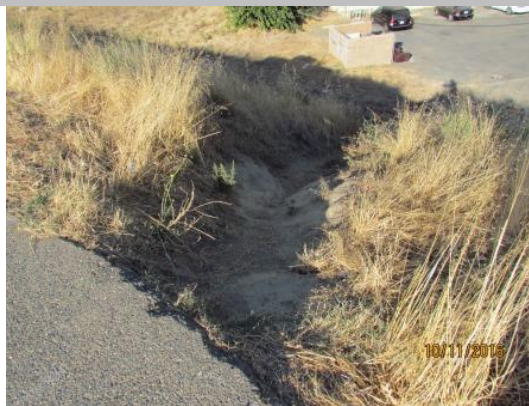
Photo 1 of 1 : SP_2017_NA0004_106_33_20170316_00013.jpg

View of path cut in by foot traffic on the landside slope that needs repaired.

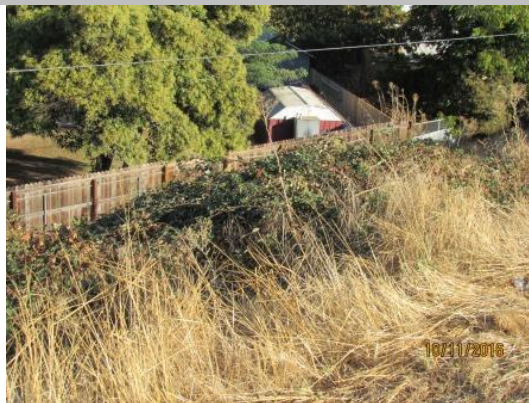
Photo 1 of 1 : SP_2017_NA0004_106_36_20170316_00016.jpg

View of Blackberry bush that is covering landside levee slope.

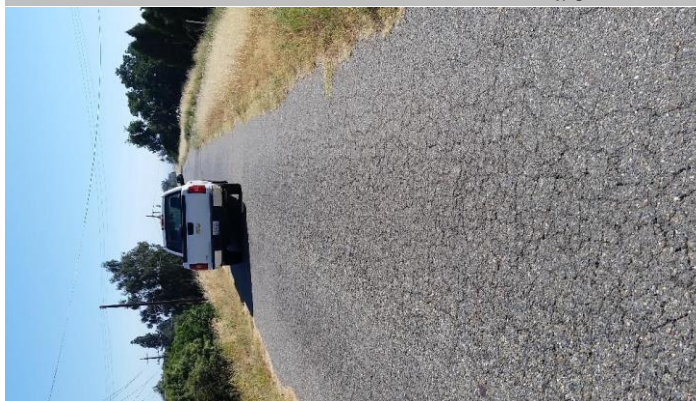
Photo 1 of 3 : UCIP_SP_2017_49951_75777.jpg

View of levee crown at crossing.

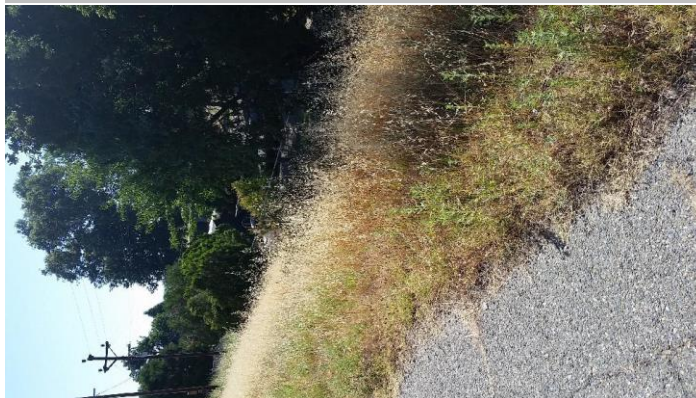
Photo 2 of 3 : UCIP_SP_2017_49951_75778.jpg

View of WS--dense vegetation on slope.

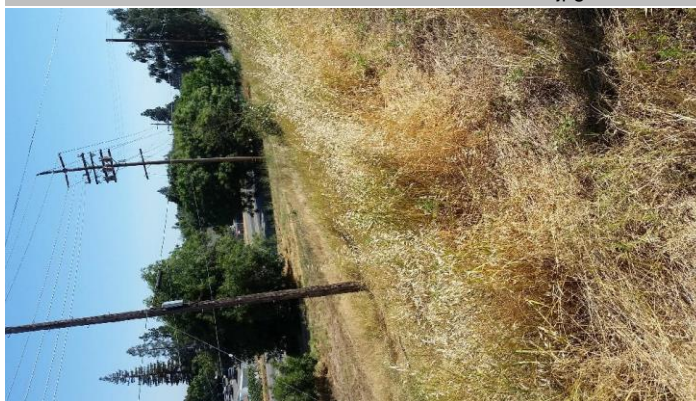
Photo 3 of 3 : UCIP_SP_2017_49951_75779.jpg

View of LS--dense vegetation on slope.

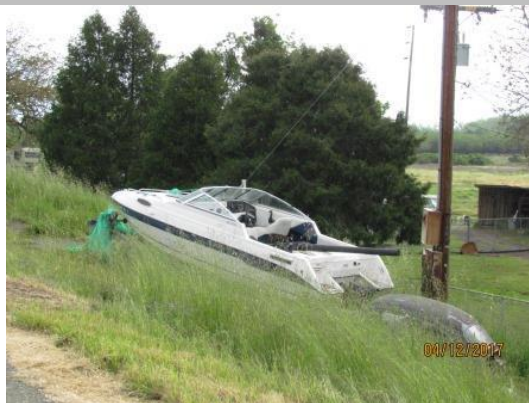
Photo 1 of 1 : SP_2017_NA0004_106_37_20170414_00068.jpg

View looking upstream of boat and car in waterside levee slope, Spring 2017.

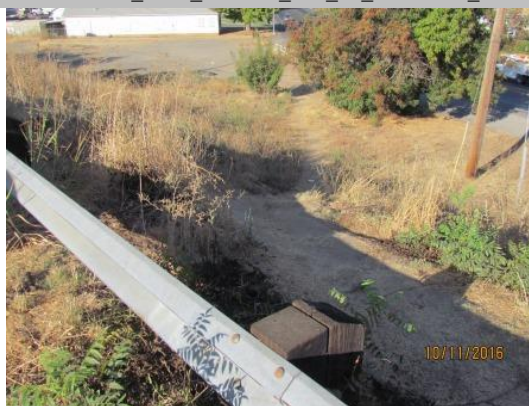
Photo 1 of 1 : SP_2017_NA0004_106_18_20170316_00006.jpg

View of foot path that has cut into landside levee slope.

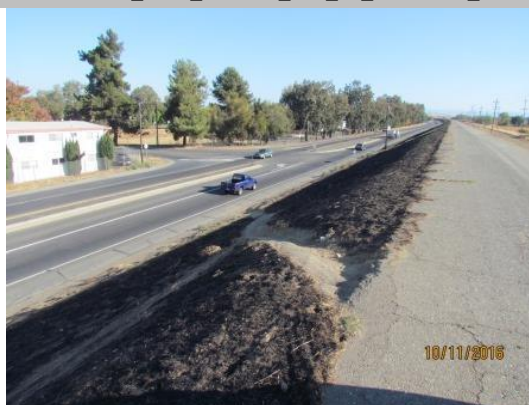
Photo 1 of 1 : SP_2017_NA0004_106_39_20170316_00017.jpg

View looking upstream of foot path that has cut into the landside levee slope.

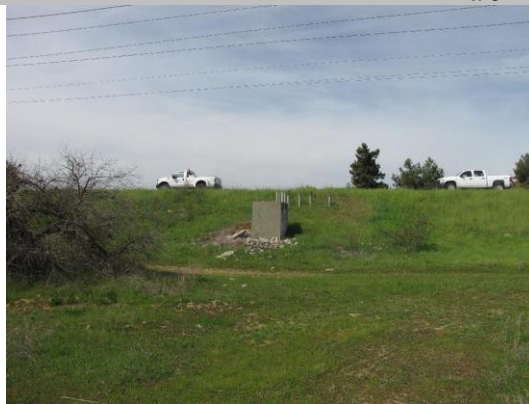
Photo 2 of 3 : UCIP_SP_2017_40999_69829.jpg

View of waterward side--concrete box and vent pipes located on waterward slope.

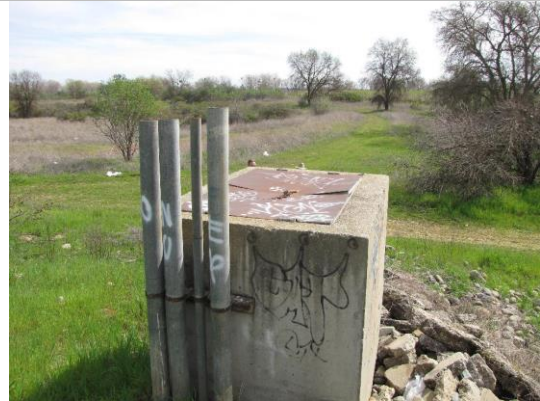
Photo 3 of 3 : UCIP_SP_2017_40999_69828.jpg

Concrete box and vent pipes located on waterward side.

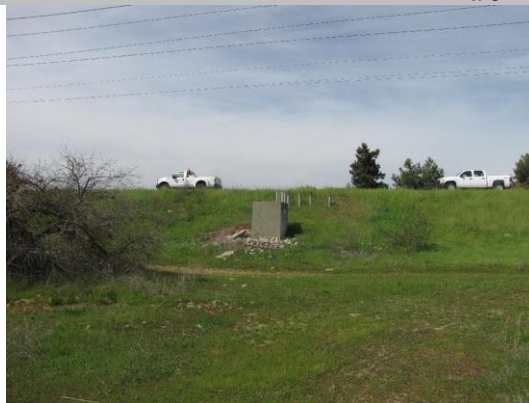
Photo 2 of 3 : UCIP_SP_2017_40998_69834.jpg

Concrete box and vent pipes located on waterward slope.

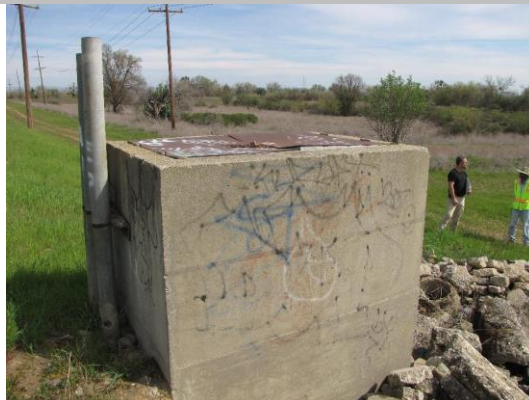
Photo 3 of 3 : UCIP_SP_2017_40998_69833.jpg

Concrete box located on waterward slope.

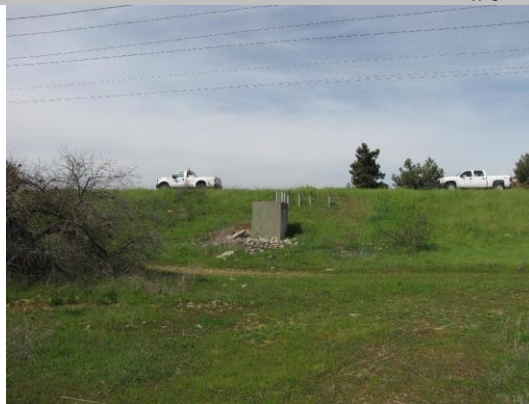
Photo 2 of 3 : UCIP_SP_2017_41000_69839.jpg

View of waterward side.

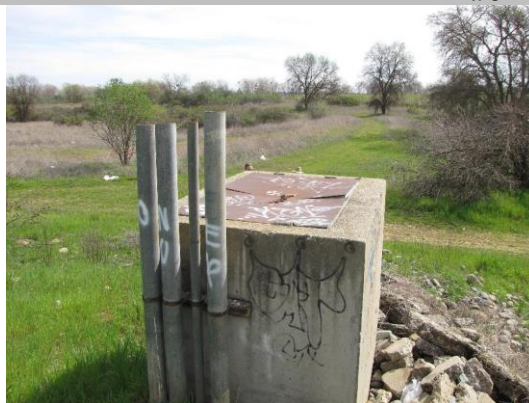
Photo 3 of 3 : UCIP_SP_2017_41000_69838.jpg

Concrete stand pipe located on waterward shoulder.

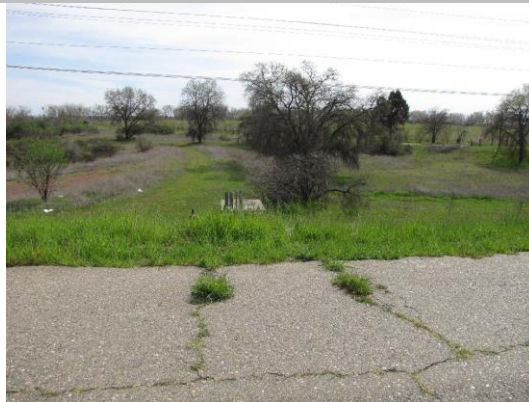
Photo 2 of 3 : UCIP_SP_2017_41001_69826.jpg

View of waterward side.

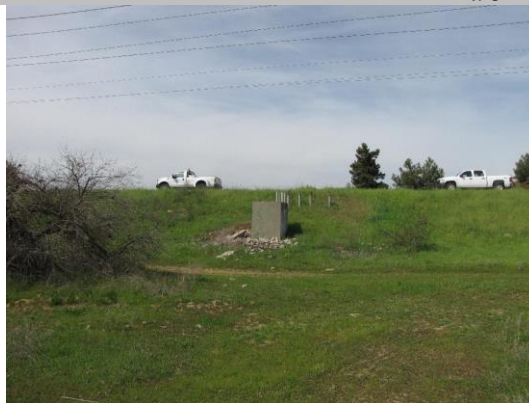
Photo 3 of 3 : UCIP_SP_2017_41001_69820.jpg

View of waterward side--concrete distribution box and gate stems located on waterward slope.

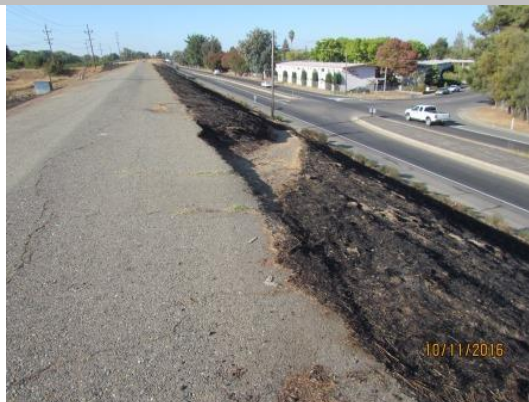
Photo 1 of 1 : SP_2017_NA0004_106_40_20170316_00018.jpg

View looking downstream of foot path that has cut into the landside levee slope.

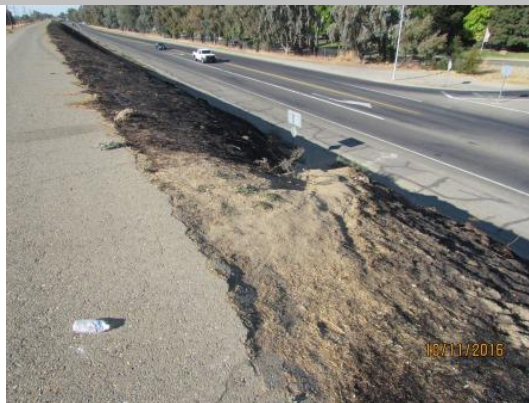
Photo 1 of 1 : SP_2017_NA0004_106_41_20170316_00019.jpg

View looking downstream of foot path that has cut into the landside slope.

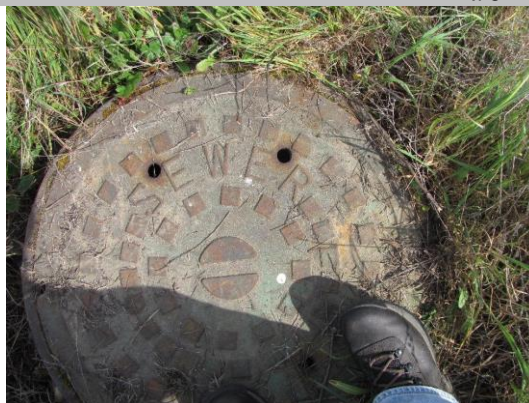
Photo 1 of 2 : UCIP_SP_2017_41002_25149.jpg

Manhole located on landward toe.

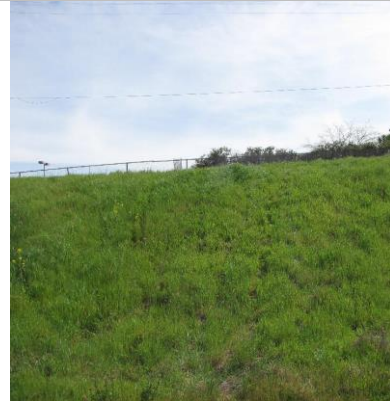
Photo 2 of 2 : UCIP_SP_2017_41002_25148.jpg

View of landward side.

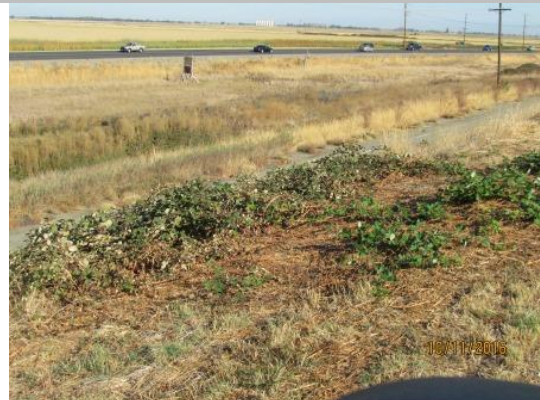
Photo 1 of 1 : SP_2017_NA0004_106_34_20170316_00014.jpg

View of Black berries that are starting to cover landside slope, looking upstream.

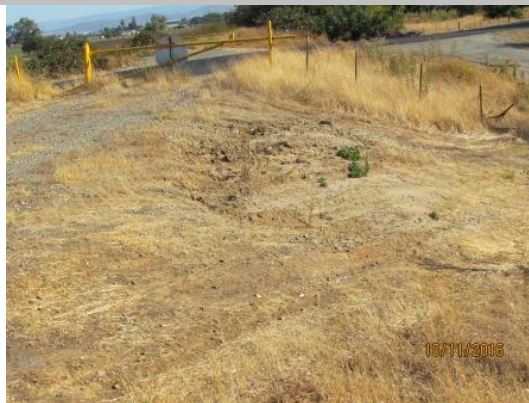
Photo 1 of 1 : SP_2017_NA0004_106_44_20170316_00022.jpg

View looking upstream of vehicle ruts on waterside slope.

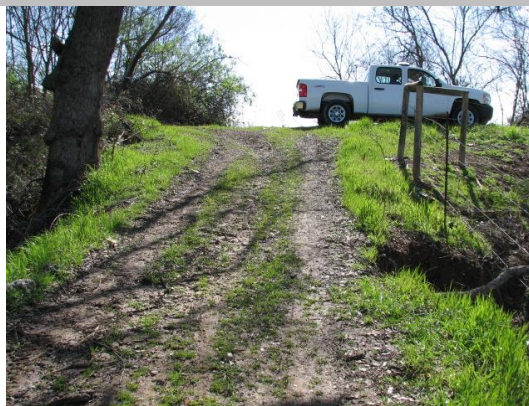
Photo 1 of 1 : SP_2017_NA0004_106_10_20170316_00005.jpg

This ramp is on the patrol road, no known permit.
